Diaphragm Seal Refurbishment Program

Giving pressure instruments a second life

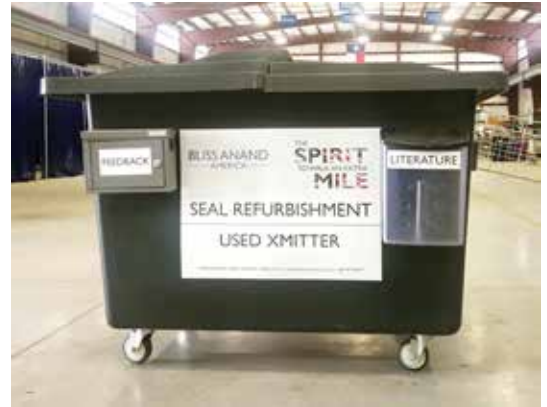
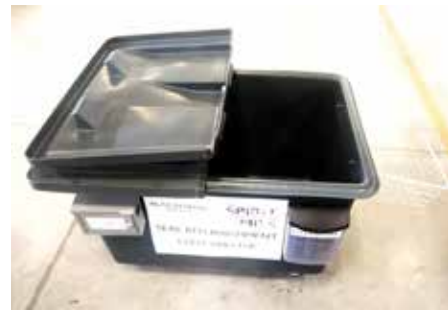
A pressure instrument with Diaphragm Seals is filled under high vacuum at a temperature of +/- 20 °C. When the instrument with Diaphragm Seals is being used at an operating temperature different to this, a measurement error will occur. When the process and/or ambient temperature increase, the filling fluid will expand resulting in a pressure build up, that will be measured by the pressure retainer on top of the actual process pressure. On request, Bliss Americas can determine the expected additional measurement error of an application, so it can be compensated in the system. It is also possible to get a reliable measurement, where the pressure instrument will be set at a given operating process temperature.
